The Kirkpatrick Group, Inc.

TWO SCREEN SHOTS FROM VIDEO SEGMENTS

Storyboard: pridepetroleum 009

“What’s Your Breaking Point?”

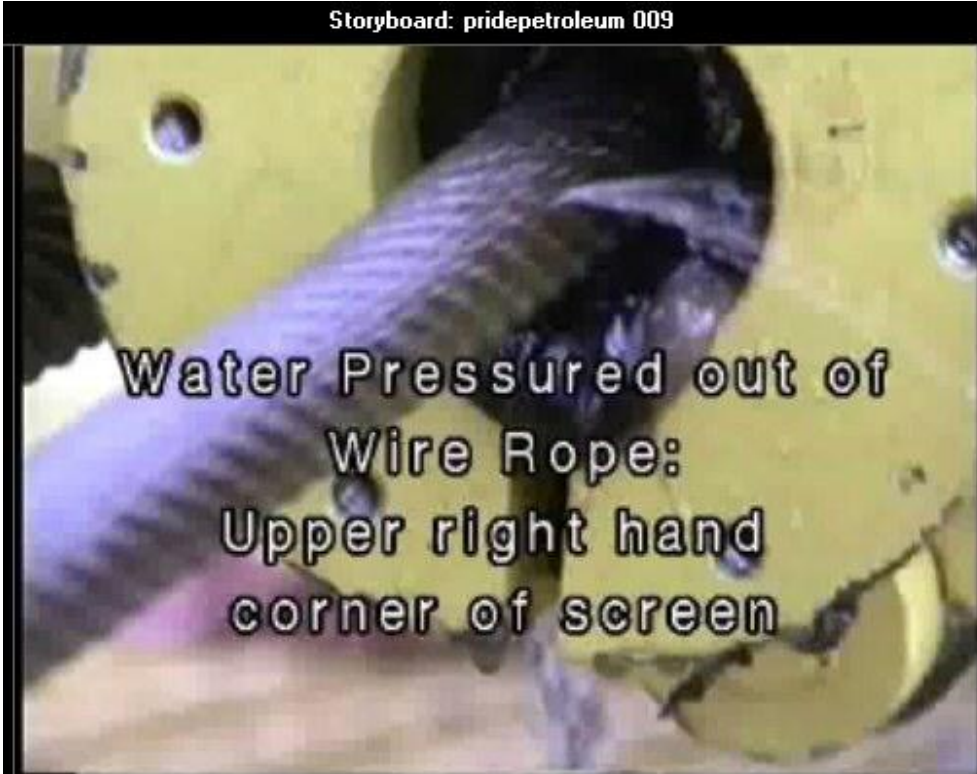
This image shows the water within the Rope being forced out by the Lubricant being pressurised into the strands.

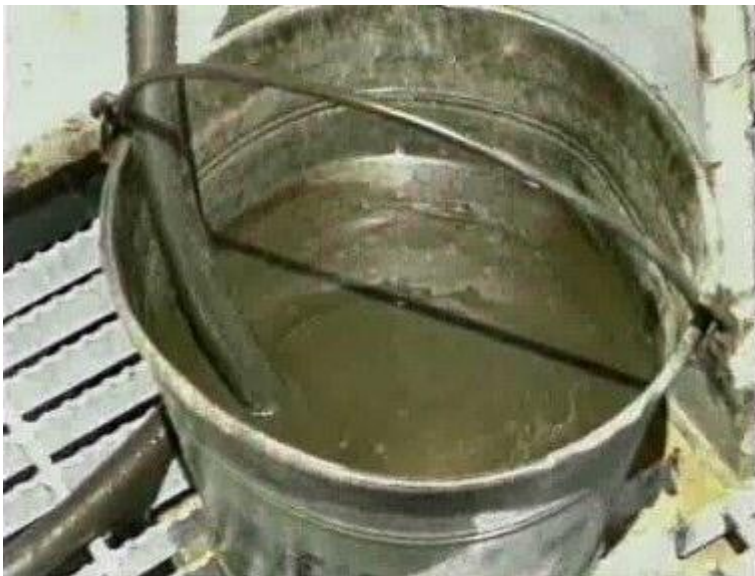
This image shows the water which has been removed from within the rope, through the discharge port. Kirkpatrick allows users the ability to drain off some lubricant from the pressure collar to allow contaminants to be removed from the system.

The Drain tube is positioned so that the lubricant must first pass through the pressure chamber before being able to escape.
